# Walk Around

## Focke-Wulf Fw 190A/F

Walk Around Number 22  
squadron/signal publications

By Malcolm Laing and E. Brown Ryle

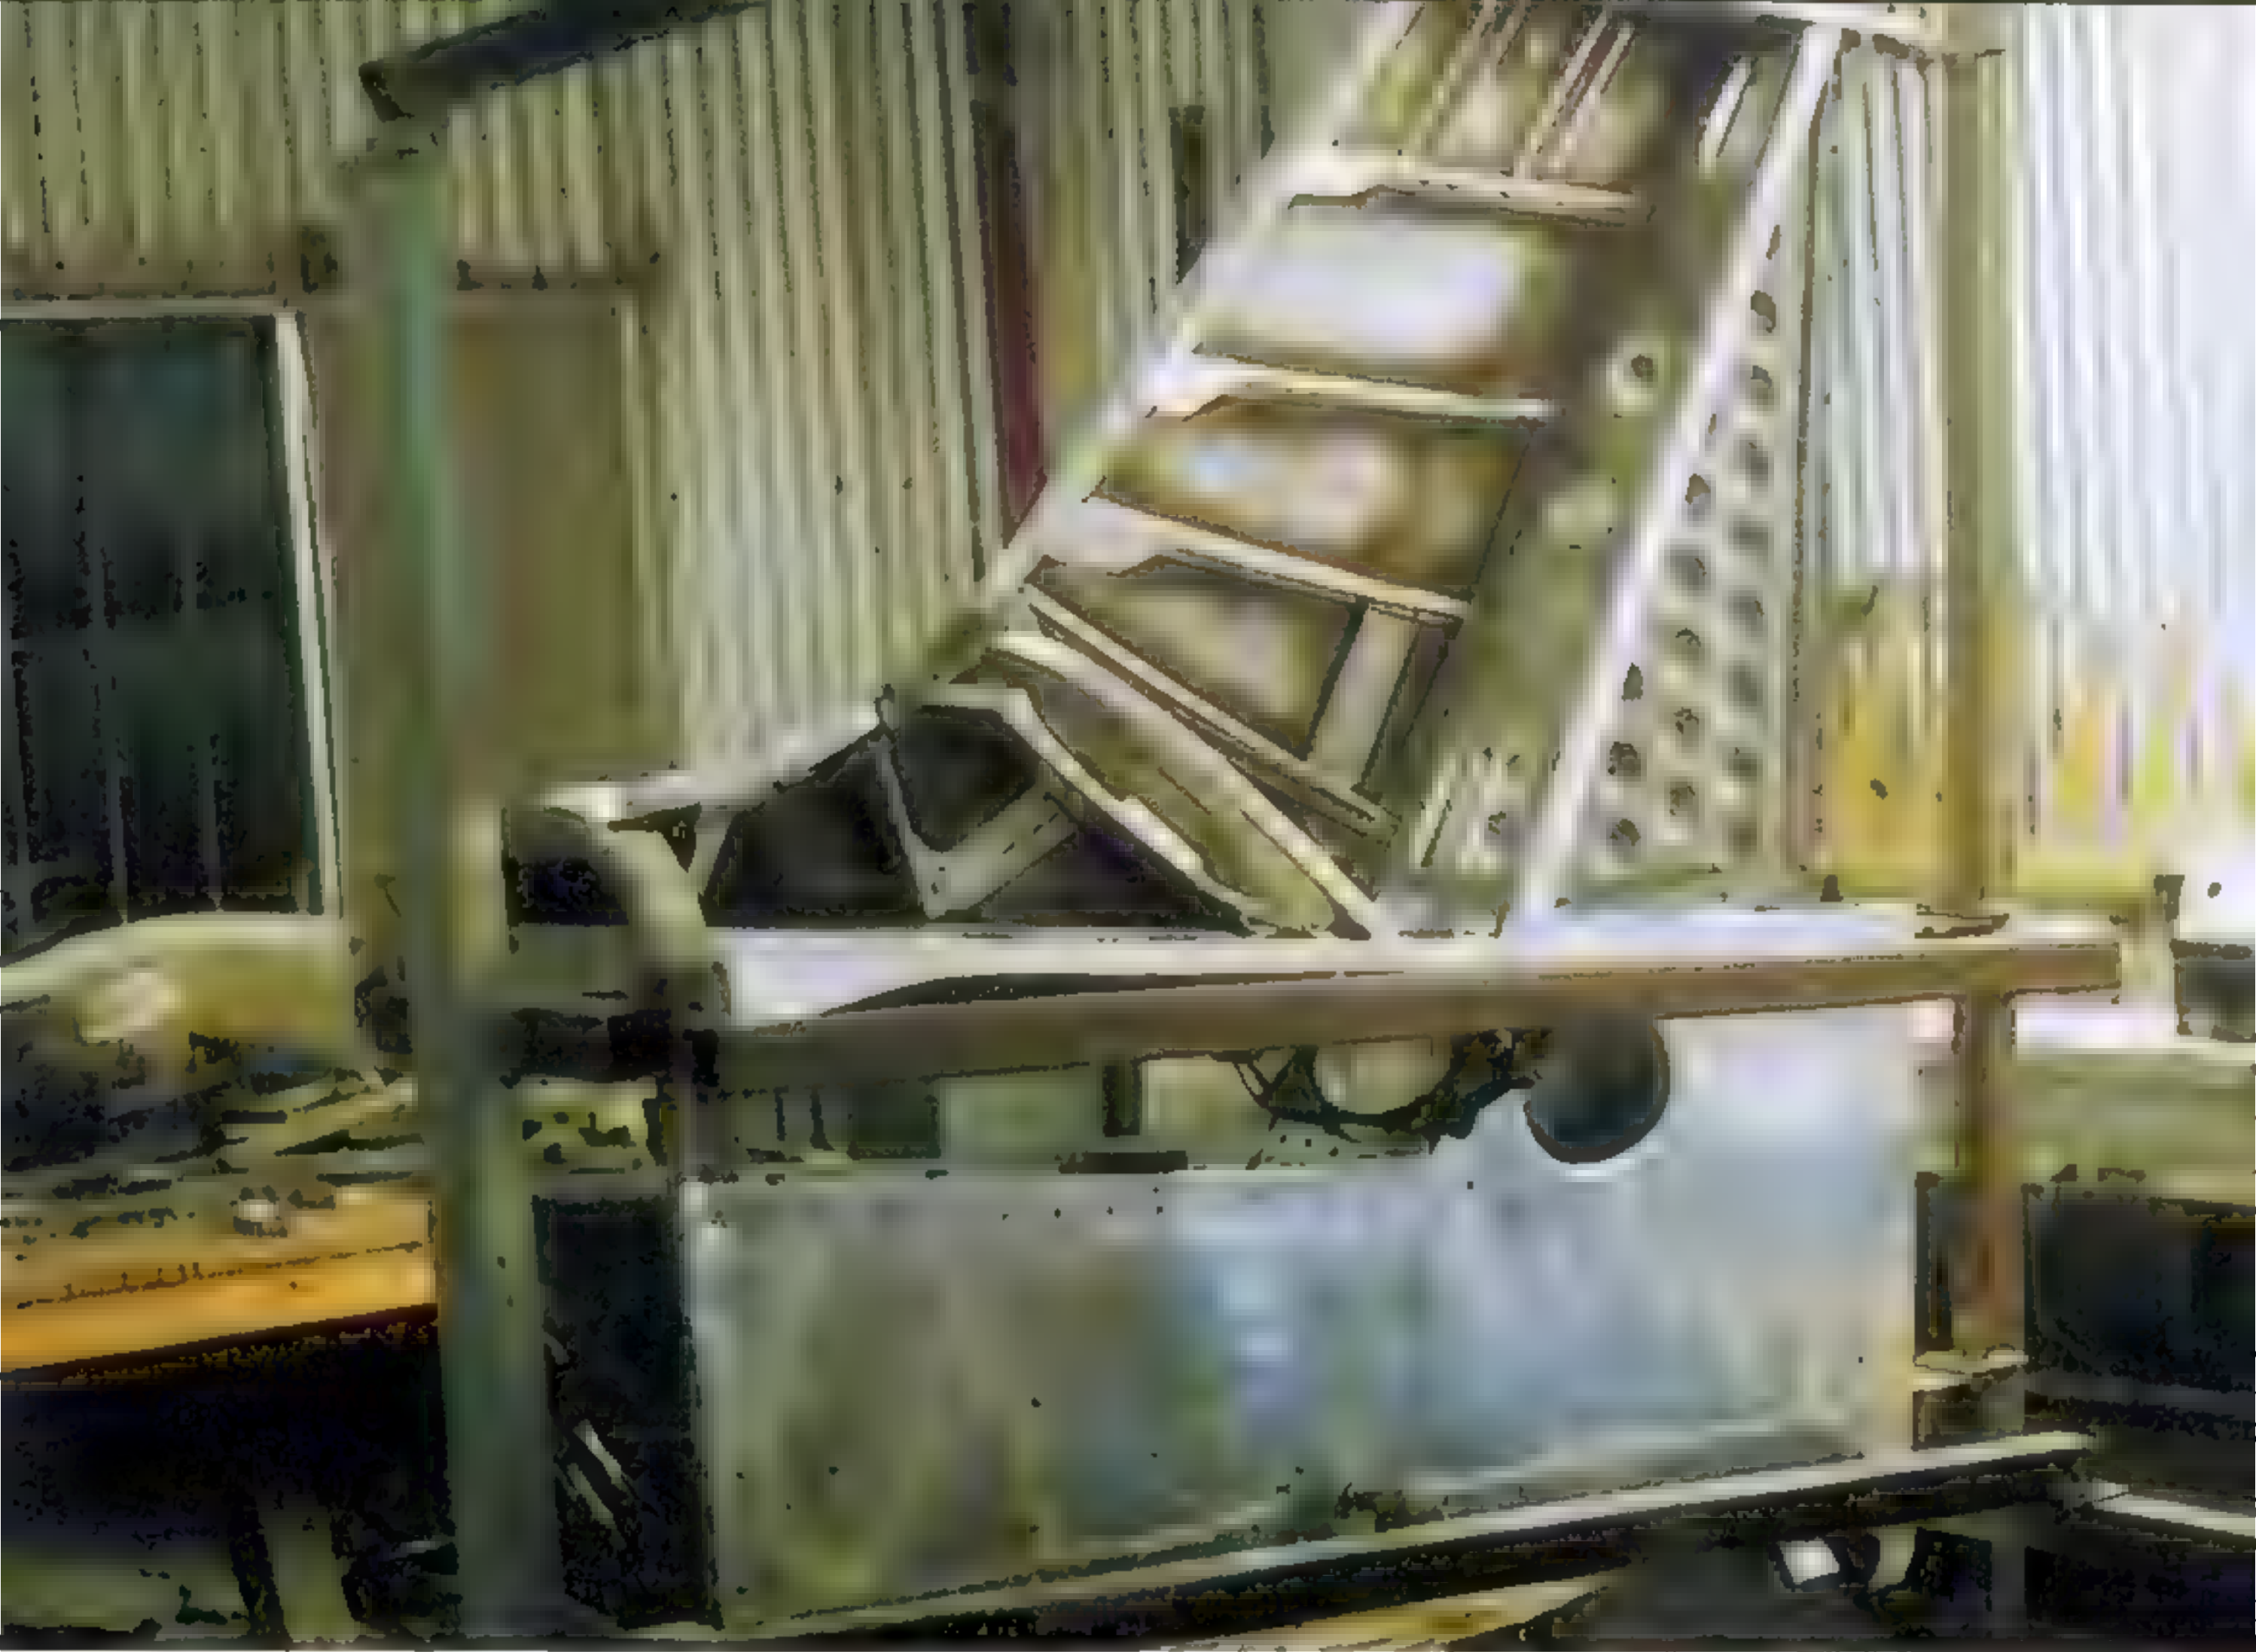
(Above Right) Restoration work at the Texas Air Museum is bringing this Fw 190A-3 tail assembly to airworthy standards. A series of canted ribs in the forward section of the vertical stabilizer provides strength and rigidity to the structure. The framework is covered with a bolted on leading edge and aluminum riveted side skinning – the starboard side skin has been installed on this example. The starboard triangular stamped section has been fitted. The electric motor for adjusting the horizontal stabilizer incidence will be installed at the base of the vertical stabilizer. (Laing)

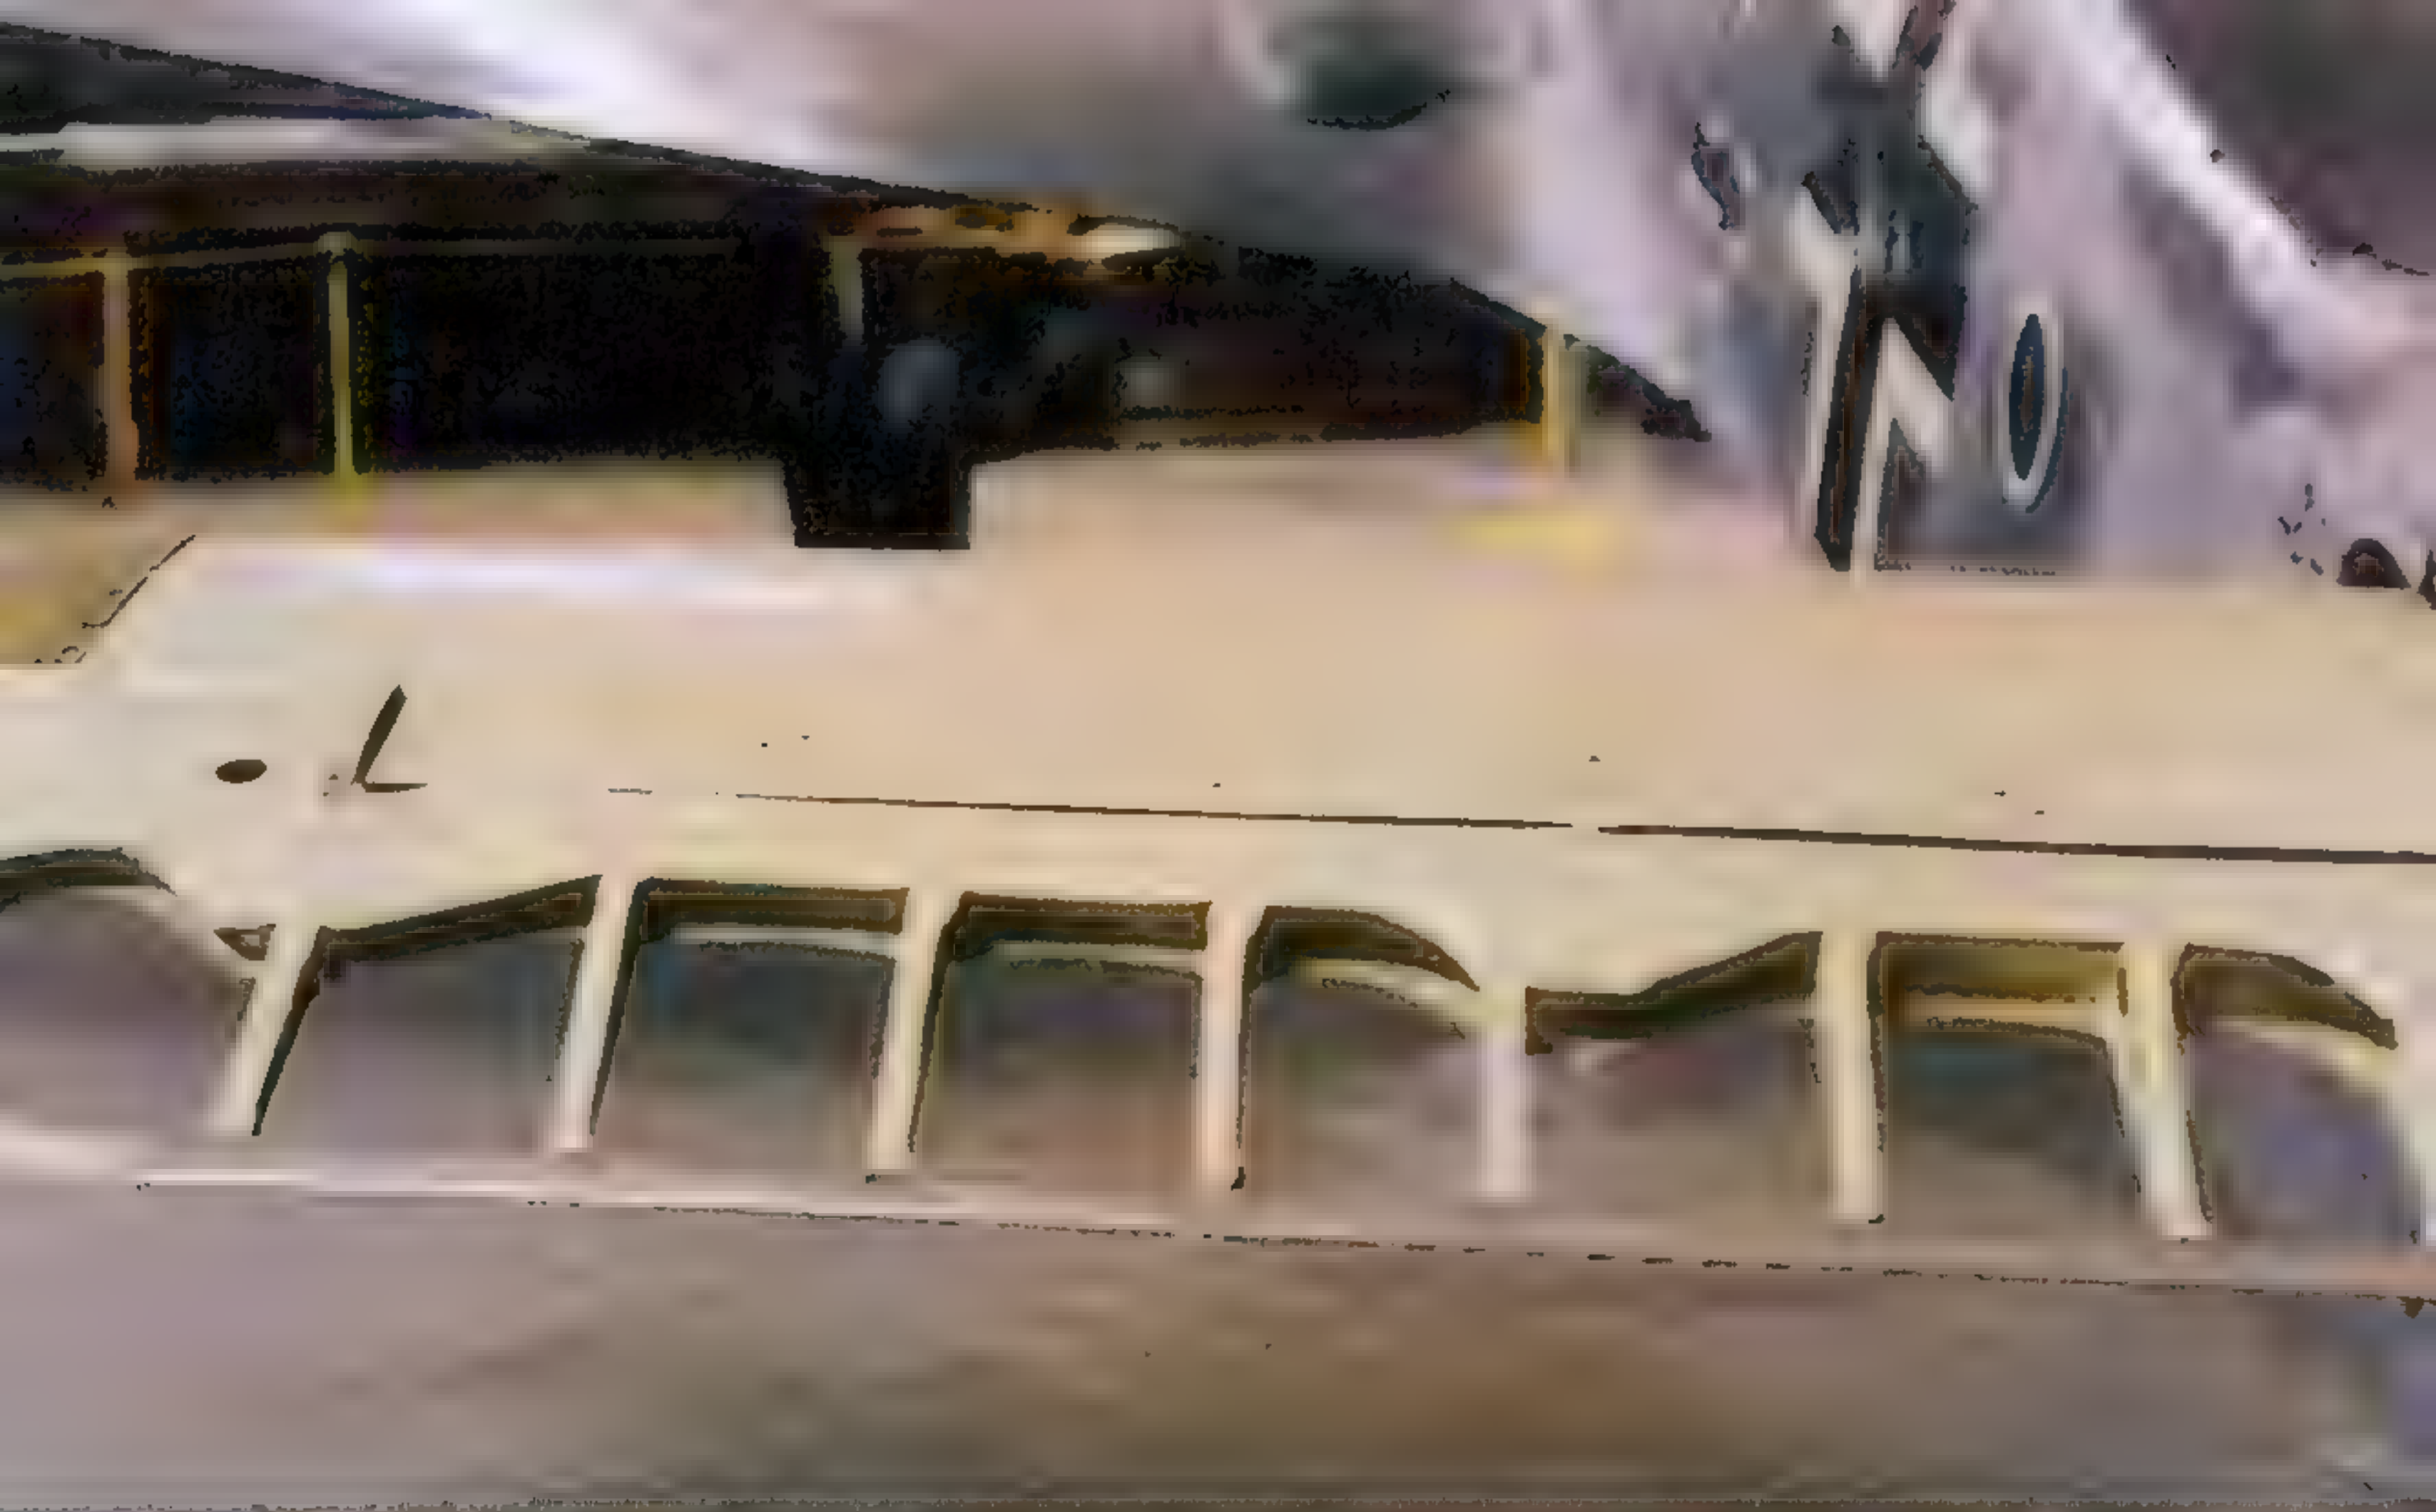
(Right) A partially assembled port horizontal stabilizer and elevator assembly is test fitted on an Fw 190A-8 at Rio Hondo. The metal parts have been given a primer coat of zinc chromate. The elevator's fabric covering will be sewed with wire onto the metal framework, then tape will be applied to the edges. The fabric is shrunk with dope prior to painting the elevator in the Fw 190's camouflage colors. (Laing)

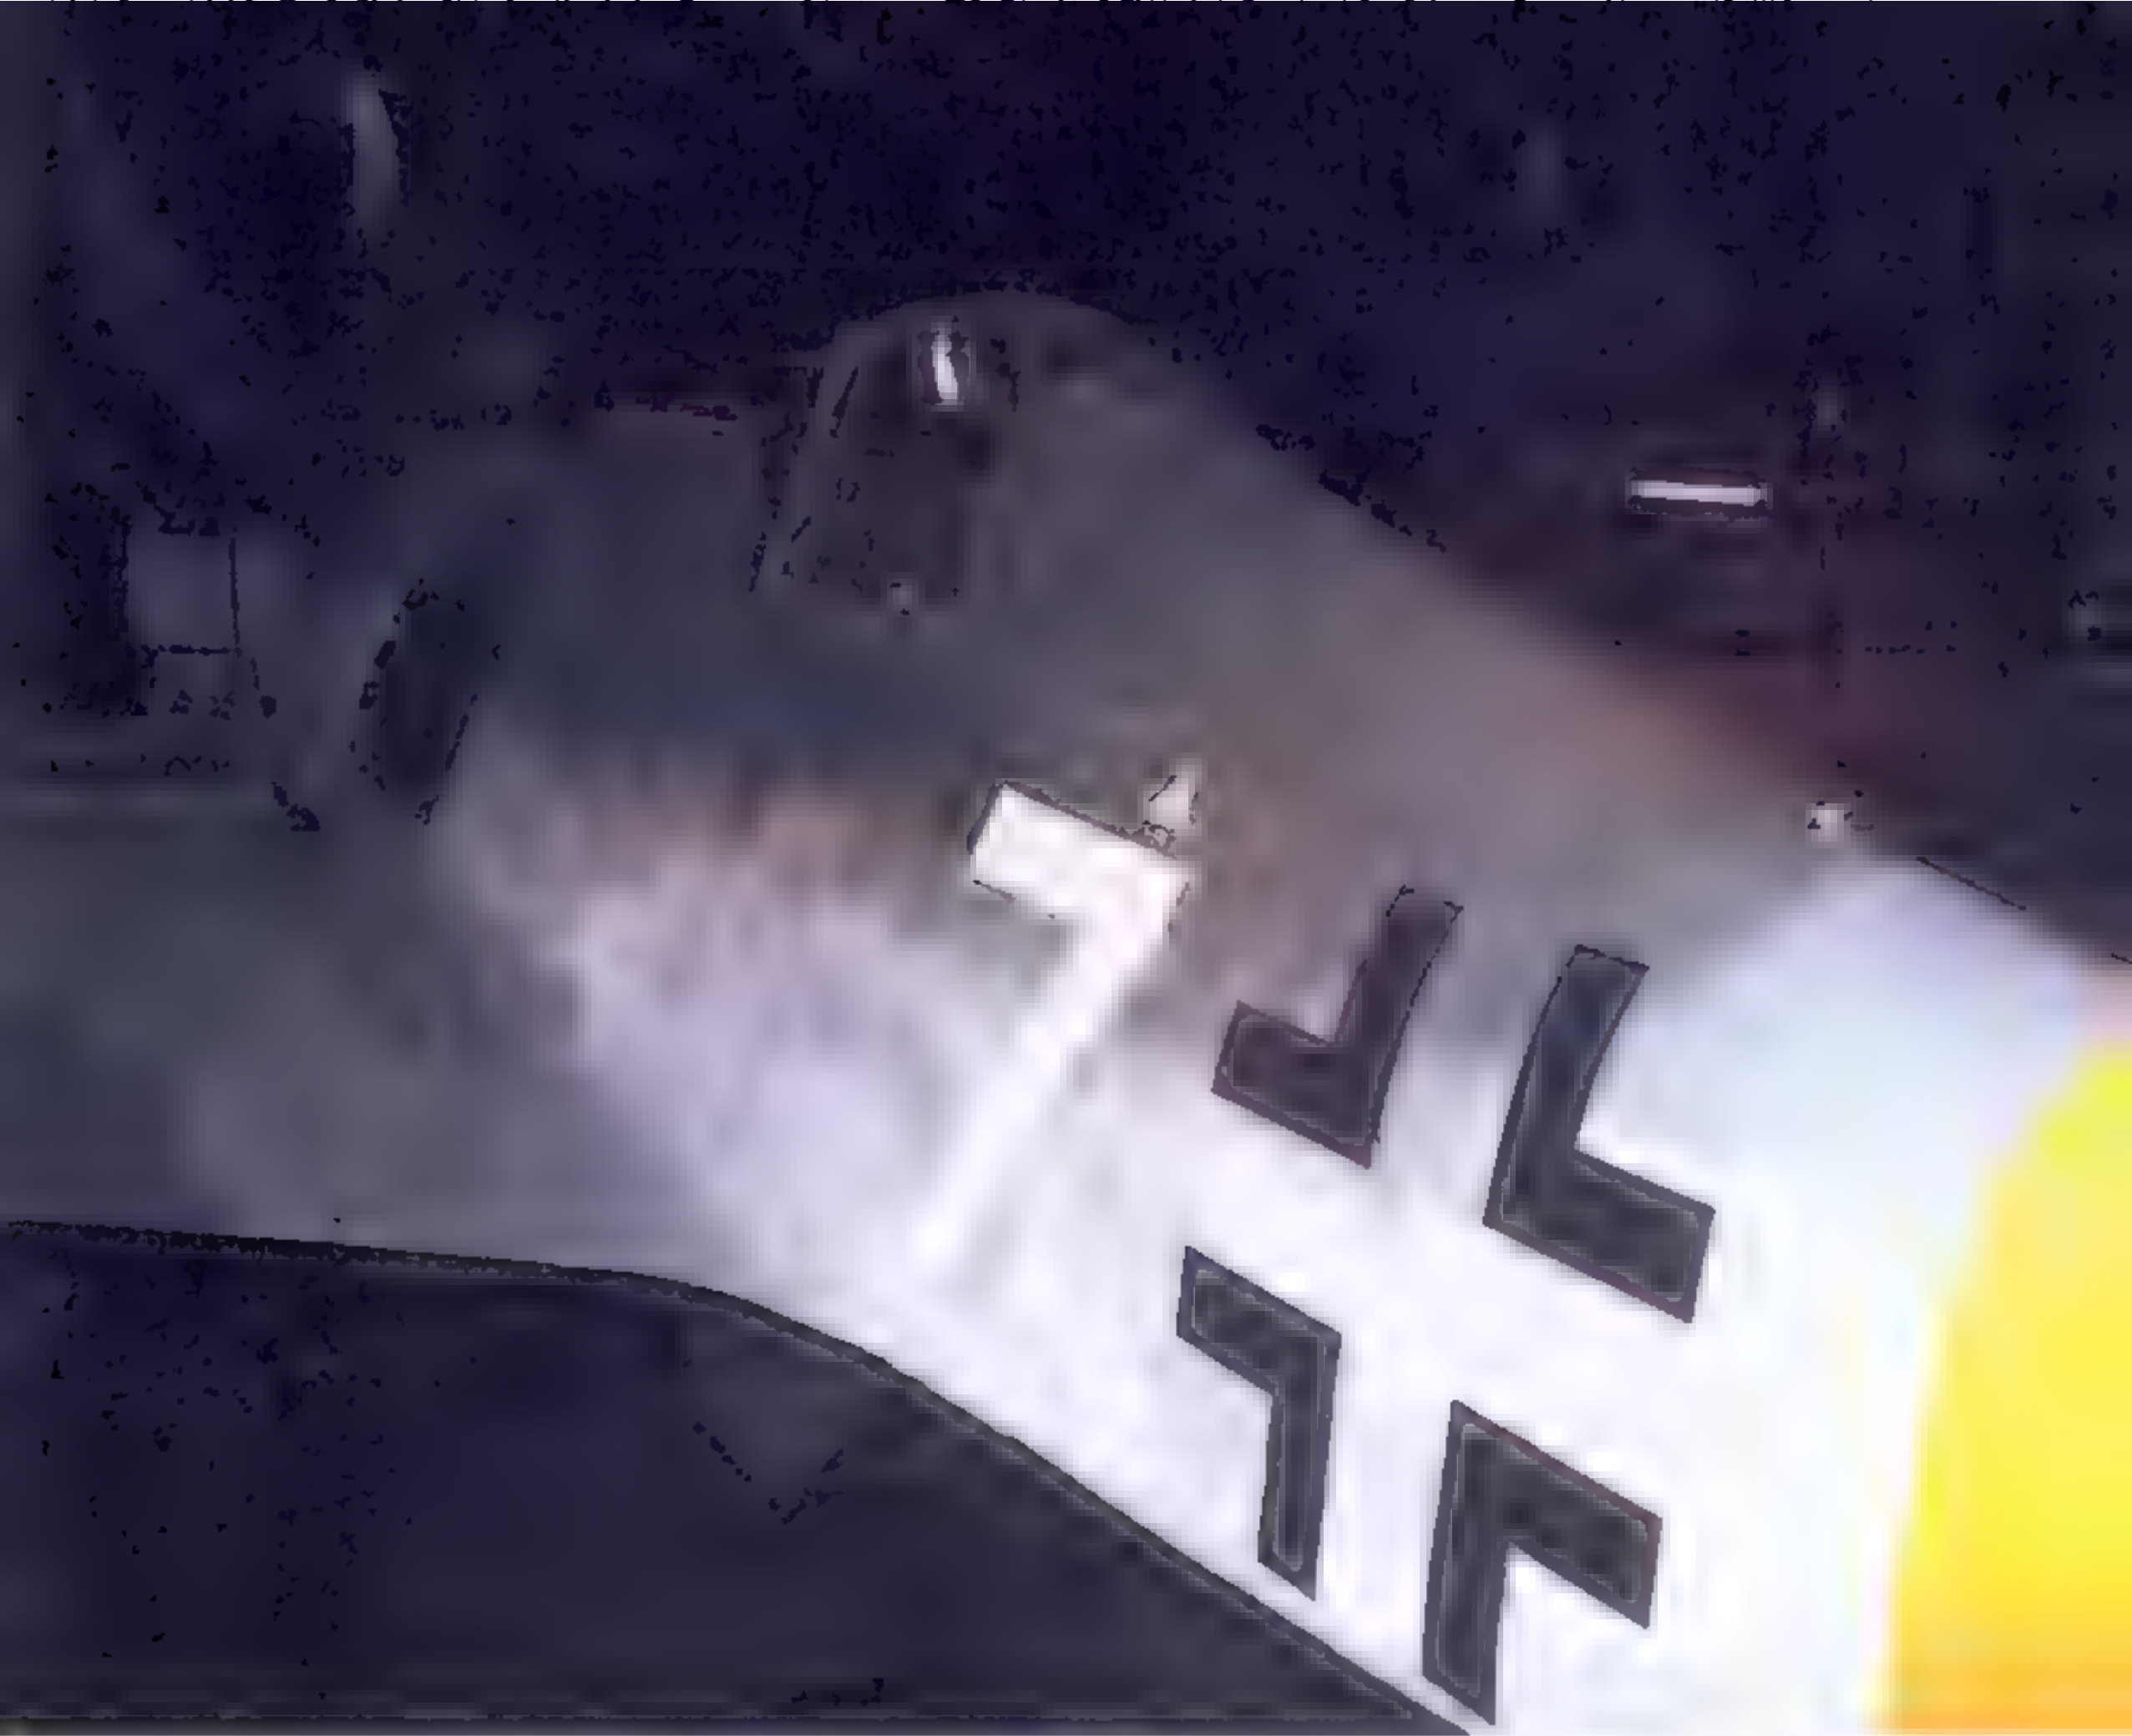
(Above) The National Air and Space Museum's Fw 190F-8 was painted RLM 70 Black Green (FS34050) and RLM 75 Gray Violet (FS36122) on the upper surfaces, with under surfaces finished in RLM 76 Light Gray (FS36473). During restoration, it was found this aircraft had tan upper surfaces over light gray under surfaces, indicating the possible use of this aircraft in the Balkans or the Mediterranean. This paint may have been applied to the airframe when this was an Fw 190A-4; however, this is not known for sure. The port side fuselage panel was upgraded to A-5 through A-9 style during rebuilding to F-8 standard with a larger fuselage access door. (Ryle)

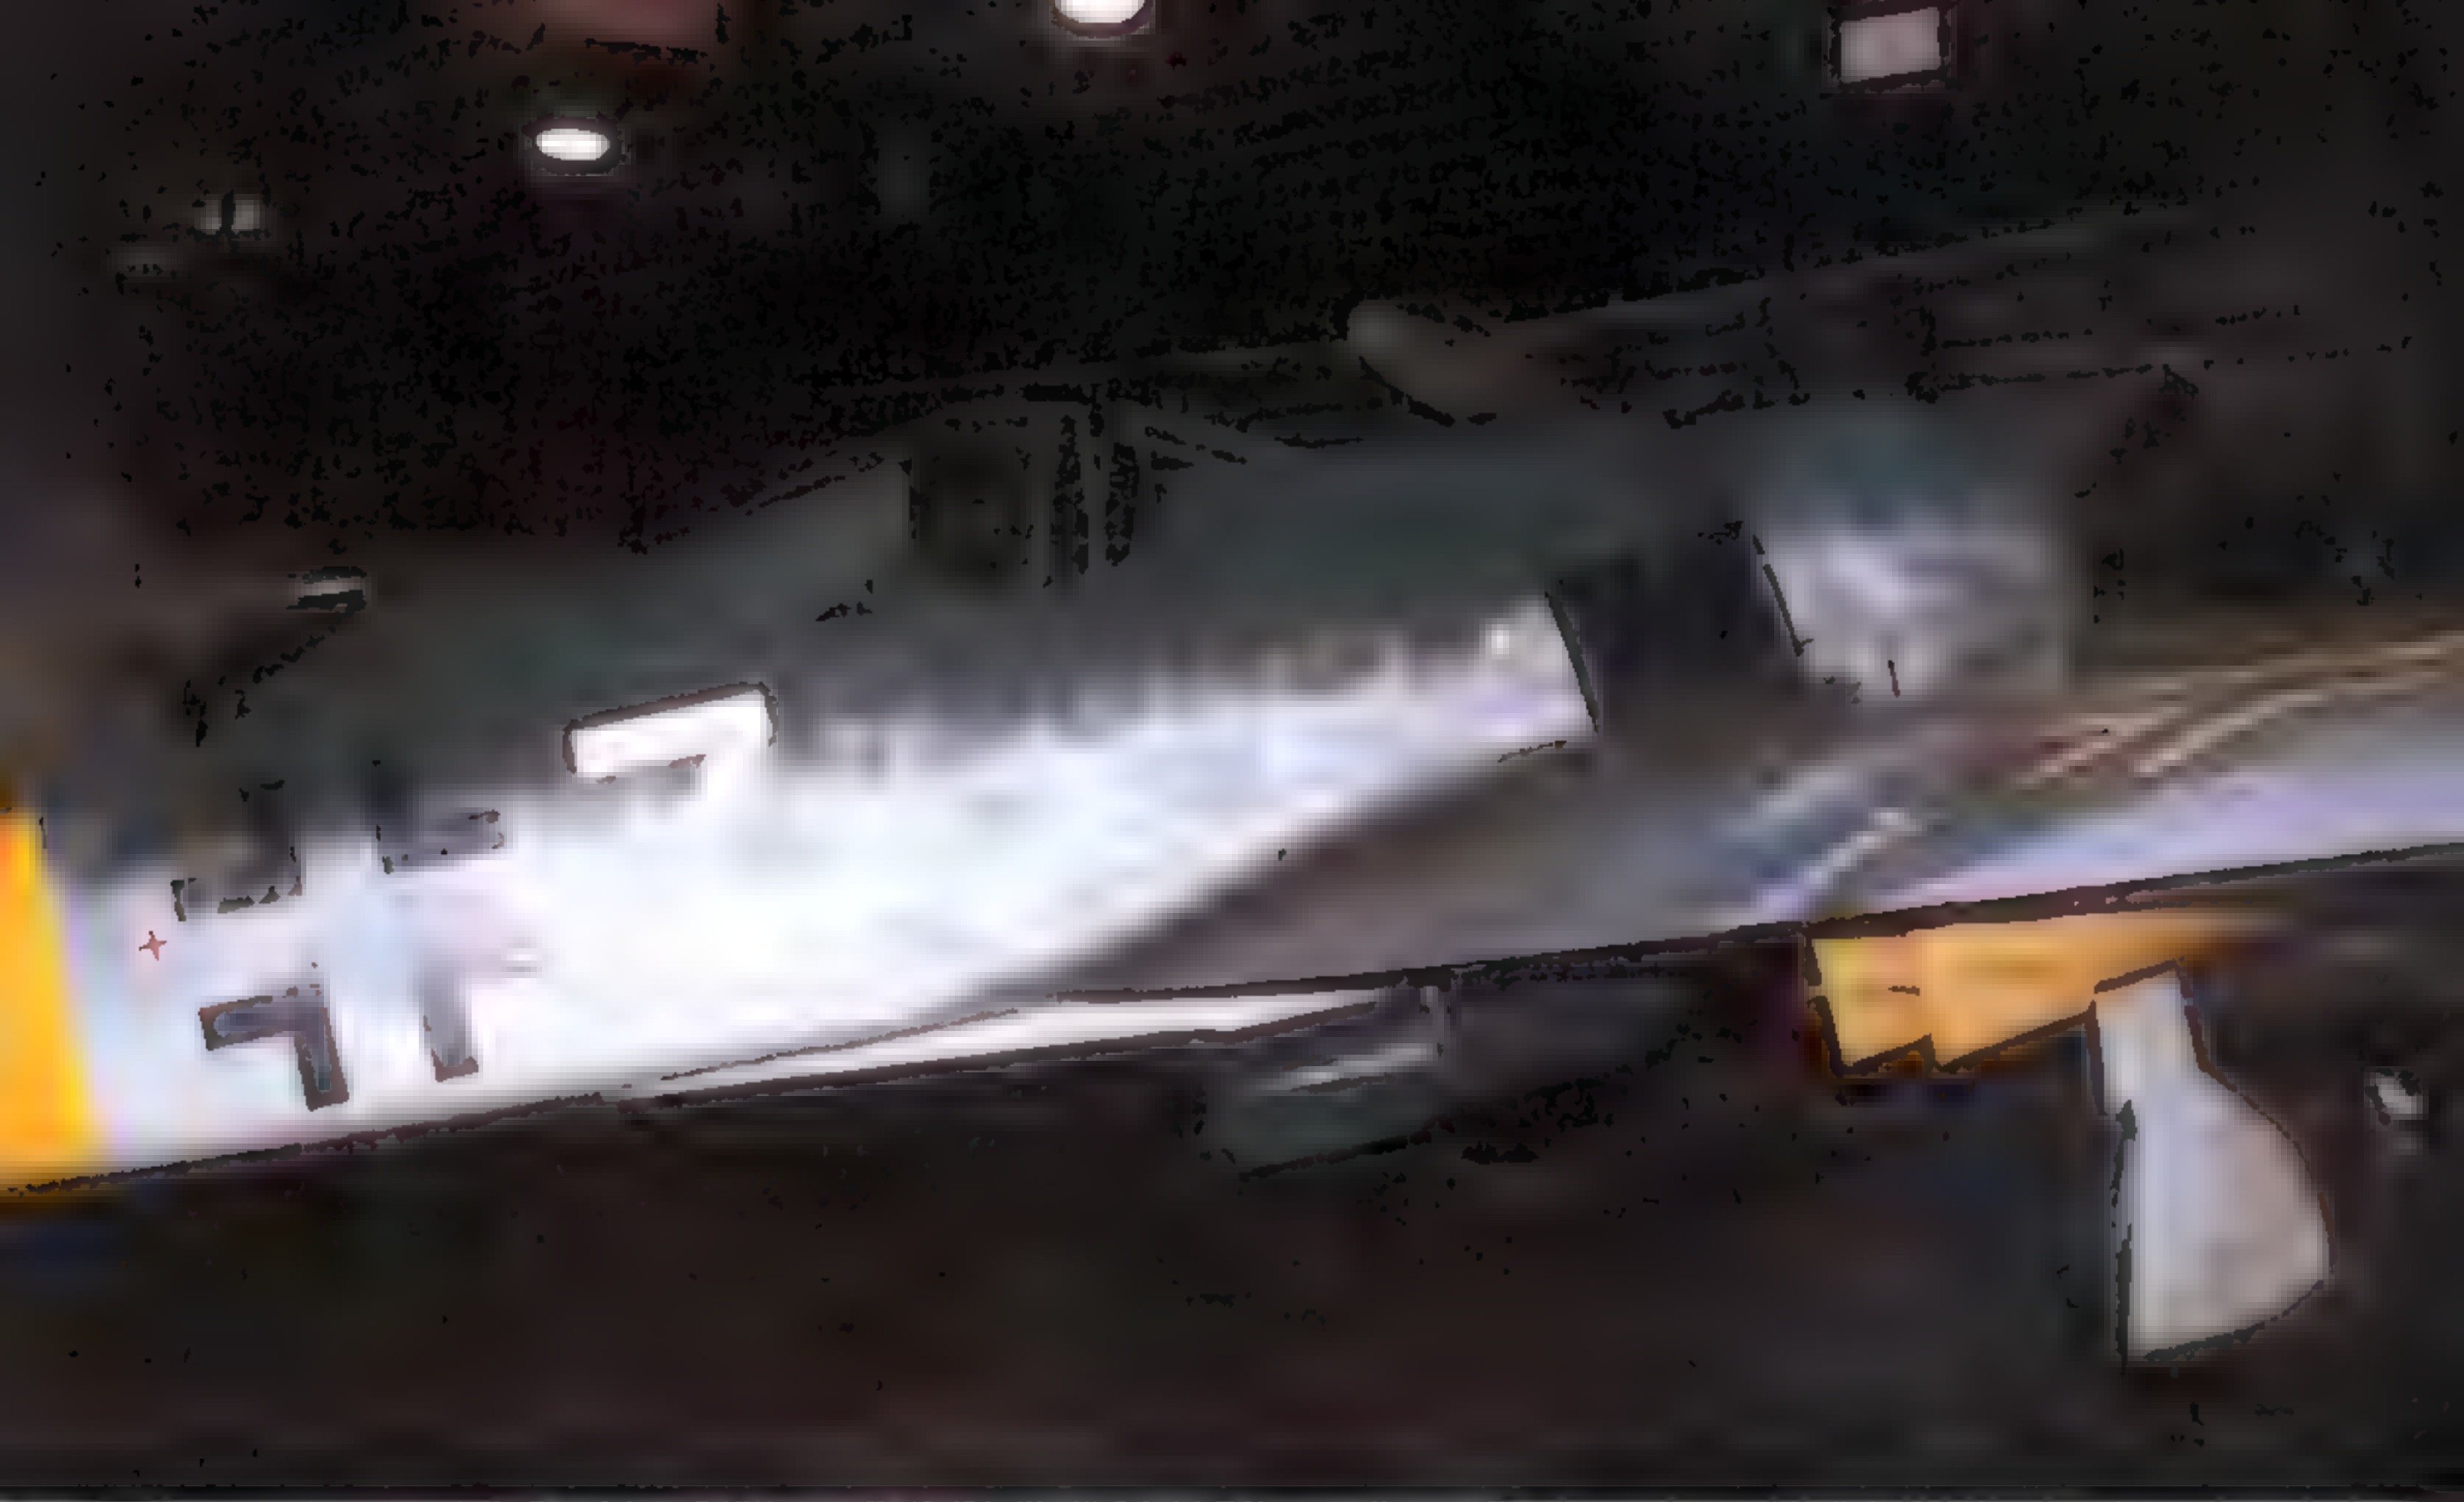
(Above Left) Fw 190F-8/R1, White 7 (W.Nr. 931884) was built as an A-4 (W.Nr. 640069) by Arado at Warnemunde, Germany. In early 1944 this aircraft was rebuilt to F-8 standards by Fieseler and its *Werk Nummer* (Factory Number) changed to 931884. This Fw 190F-8 saw action with I/SG 2 (*Schlachtgeschwader*, Attack Wing) on the Eastern Front against the Soviets in 1944 and 1945. The aircraft was captured by US forces in 1945 and assigned the Foreign Aircraft Evaluation code FE-117. After the Fw 190F-8 arrived in the US, the Smithsonian Institution's National Air and Space Museum (NASM) acquired the aircraft and placed it in storage until the airframe was restored between 1980 and 1983. This Fw 190F-8 is displayed at NASM's Paul E. Garber Facility in Suitland, Maryland, just outside

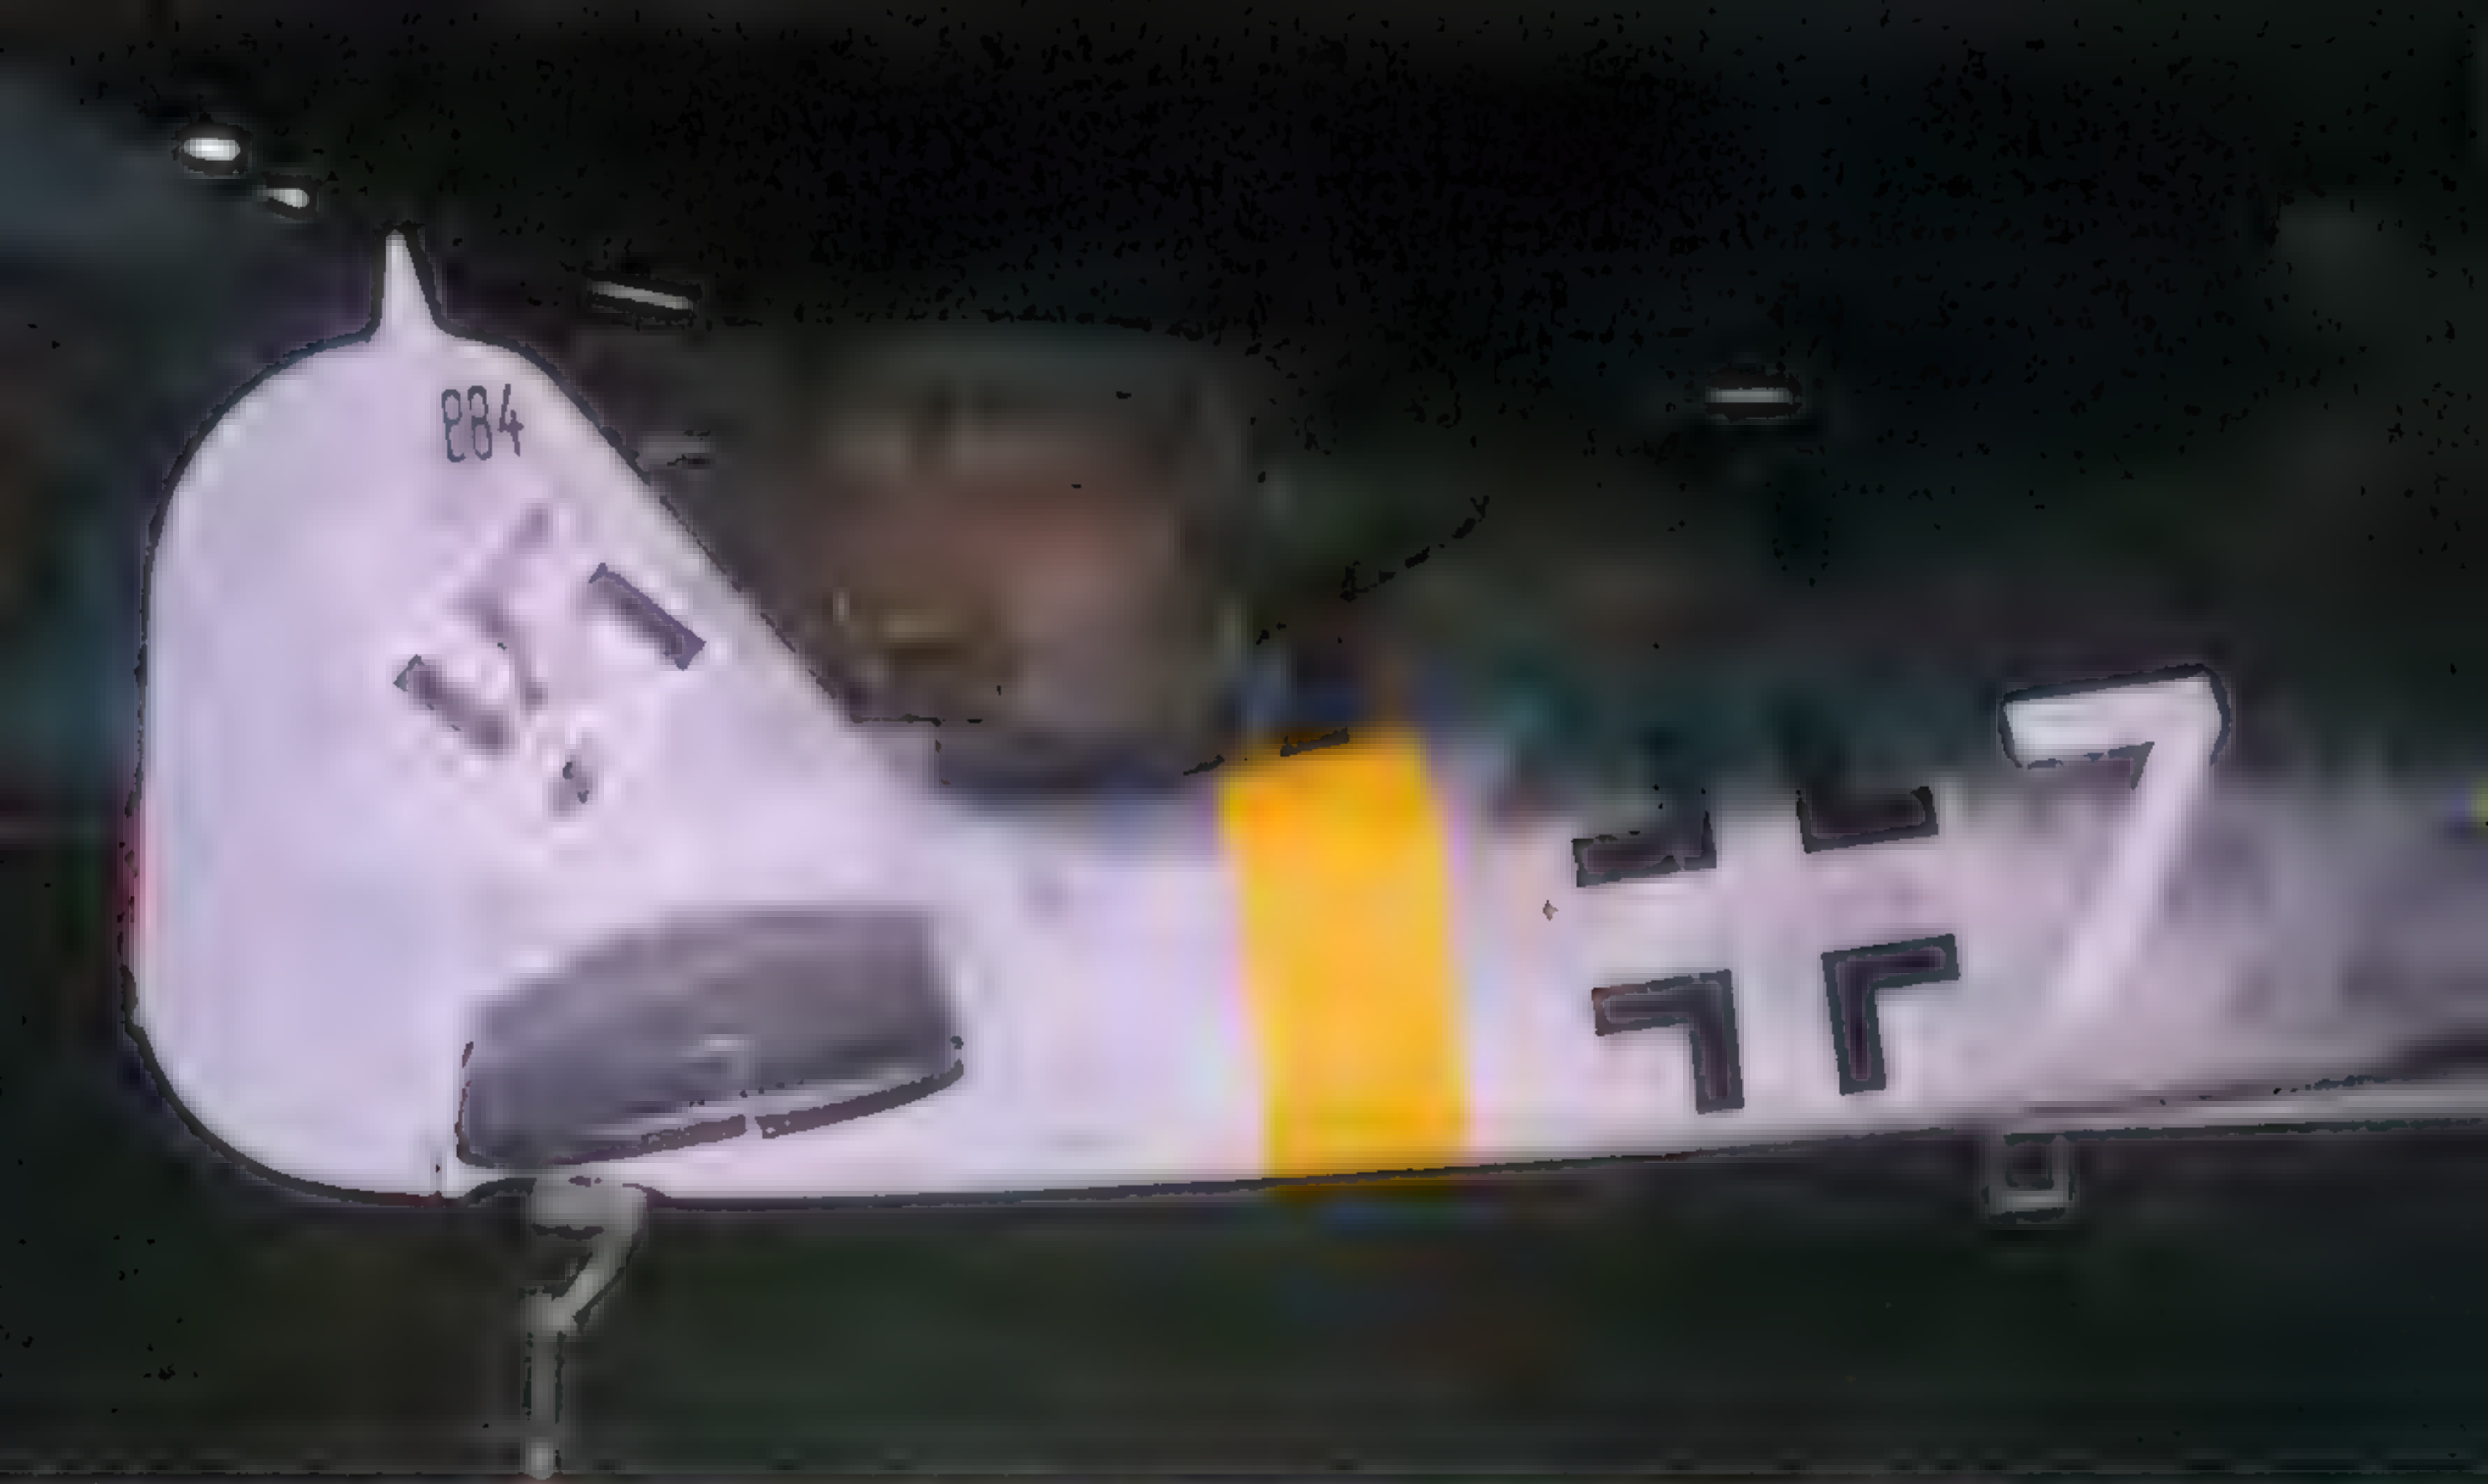
(Left) The last three digits of the Fw 190F-8's *Werk Nummer* – 884 – were hand-painted in black on the tail. The data tag inside the fuselage retains the original Fw 190F-4 W.Nr. of 640069. NASM restorers discovered this aircraft was coded White 7 and Yellow 10 in different camouflage schemes during World War II. The RLM 04 Yellow (FS33637) aft fuselage band indicated assignment to the Eastern Front. (Ryle)
